**Phase I
Phase I Environmental Site Assessment**

**Former Saint Johnsbury Armory
VT DEC Site #2010-4075
(SMAC September 7, 2010)
1249 Main Street
Saint Johnsbury, Vermont**

May 2012

**Prepared for:
VTDEC Sites Management Section
103 South Main Street
Waterbury, VT**

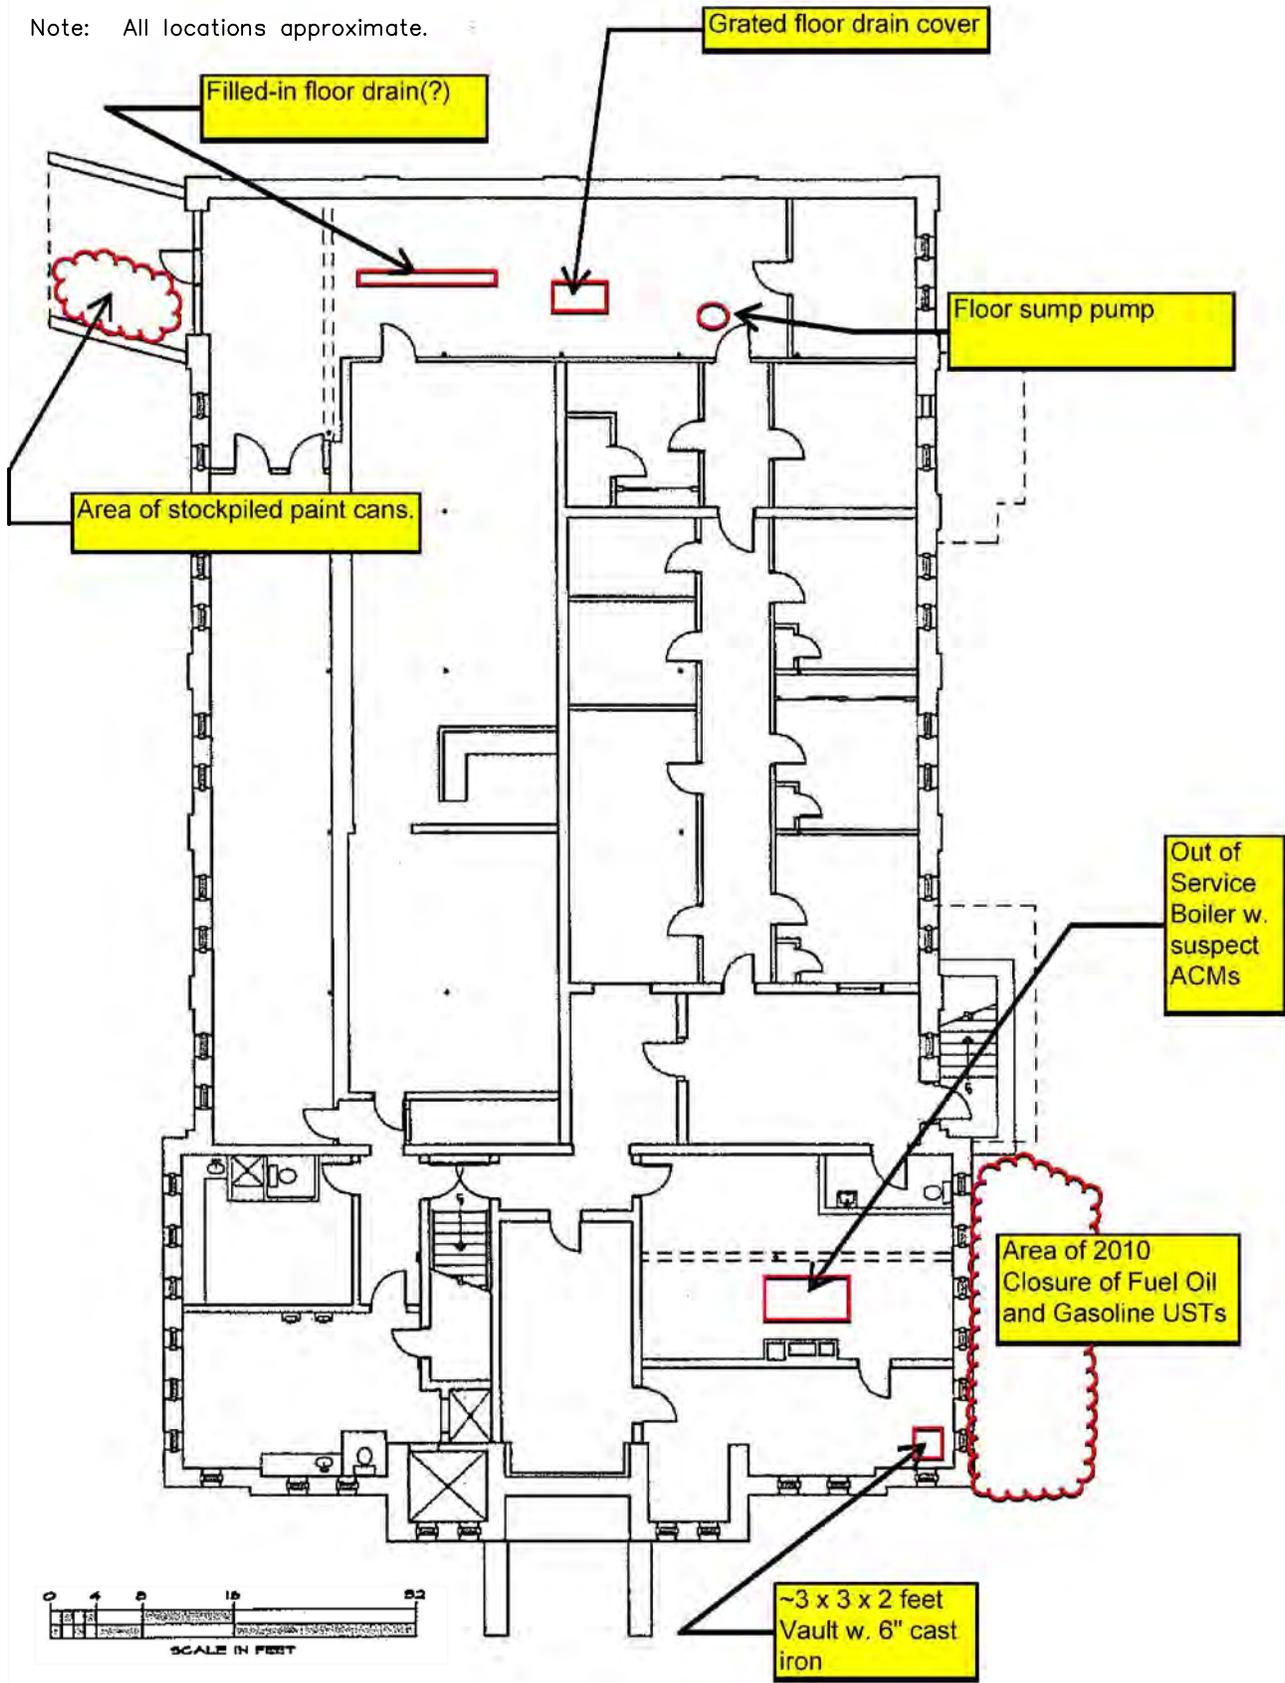
**FIGURE 3: ARMORY BUILDING BASEMENT FLOOR PLAN
SAINT JOHNSBURY ARMORY PROPERTY
SAINT JOHNSBURY, VERMONT**

- b. A filled-in structure (approximately 7 feet long by 1 foot wide) was observed in the floor of the basement, next to the vehicle access ramp located in the southwest portion of the Armory building basement (Figure 3). This structure has the appearance of a trench/floor drain that has been decommissioned. Jim Rust (Town of St Johnsbury) indicated to The Johnson Company that in years past when the building operated as the Armory, vehicles were stored in the basement of the Armory building, and floor drains were installed to convey surface water flow entering via the vehicle access ramp southwest corner of the building (Figure 3).

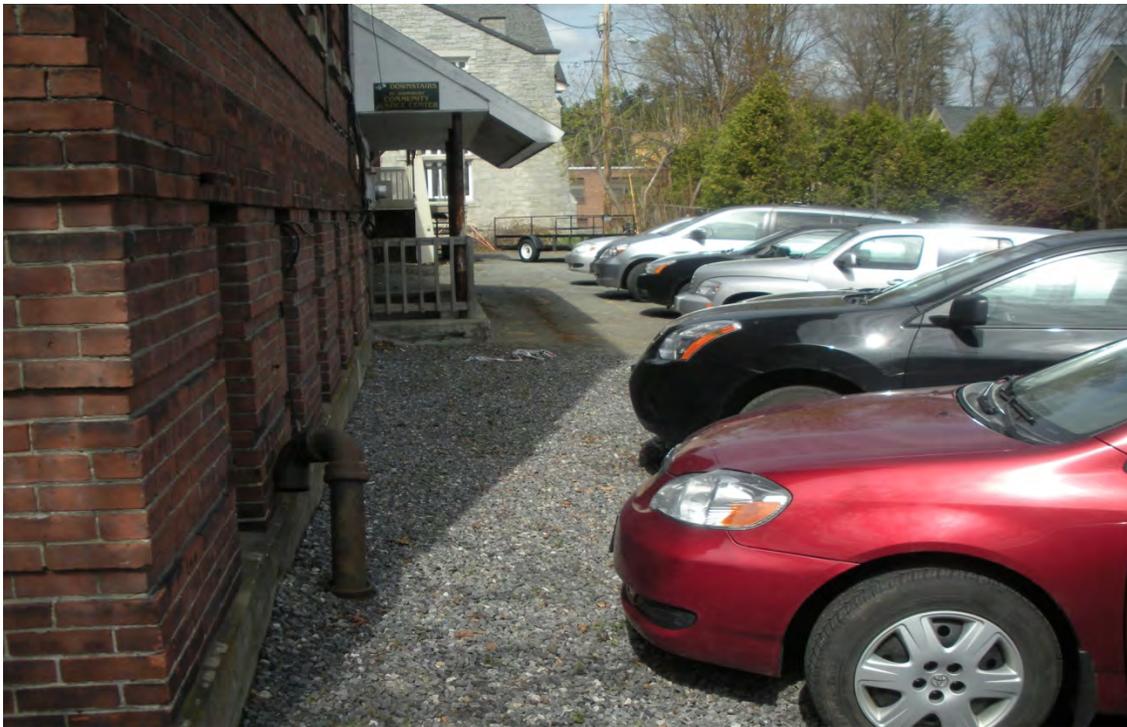
According to the July 21, 2010 Horizons Engineering (Littleton, NH) UST closure report, petroleum contaminated soils (PCS) were identified in June 2010 during the permanent closure and removal of a 1,000 gallon capacity gasoline and 6,000 gallon capacity fuel oil UST. Both USTs were observed to be in poor condition at the time of removal. No subsurface impact to underlying soil was observed with the gasoline UST and pump island ; however, elevated photo-ionization detector (PID) readings registering between 12 and 50 parts per million (ppm) were noted in the soils adjacent to piping area, the fill area and the west end of the fuel oil UST (Horizons Engineering, 2010). A total of 22 tons of PCS were removed. According to the Horizons report, following removal of the PCS, no registered PID readings were identified in excess of 10 ppm within the area of excavation. The PCS were transported off site for treatment and disposal to Environmental Soil Management Inc. (ESMI) in Loudon NH and a cleanup confirmation soil sample was collected from the base of the excavation at the west end of the UST by Horizon Engineering and submitted for laboratory analysis for total petroleum hydrocarbons (TPH) and volatile organic compounds (VOCs) using EPA Methods 8100, and 8260, respectively. The confirmatory soil sampling results revealed no detectable concentrations of VOC or TPH above method detection limits in the soil. A Sites Management Activity Complete (SMAC) designation was granted and the Site was removed from the SMS active hazardous waste site list.

Plate 2. Close up of Armory exterior area where USTs were removed. Former UST area is covered with gravel.

Recommendation: No further action is recommended with respect to the former USTs. Following their discovery during the UST closure, the PCS were identified and managed per State and Federal guidelines such that an SMAC designation was assigned to the Site September 7, 2010.

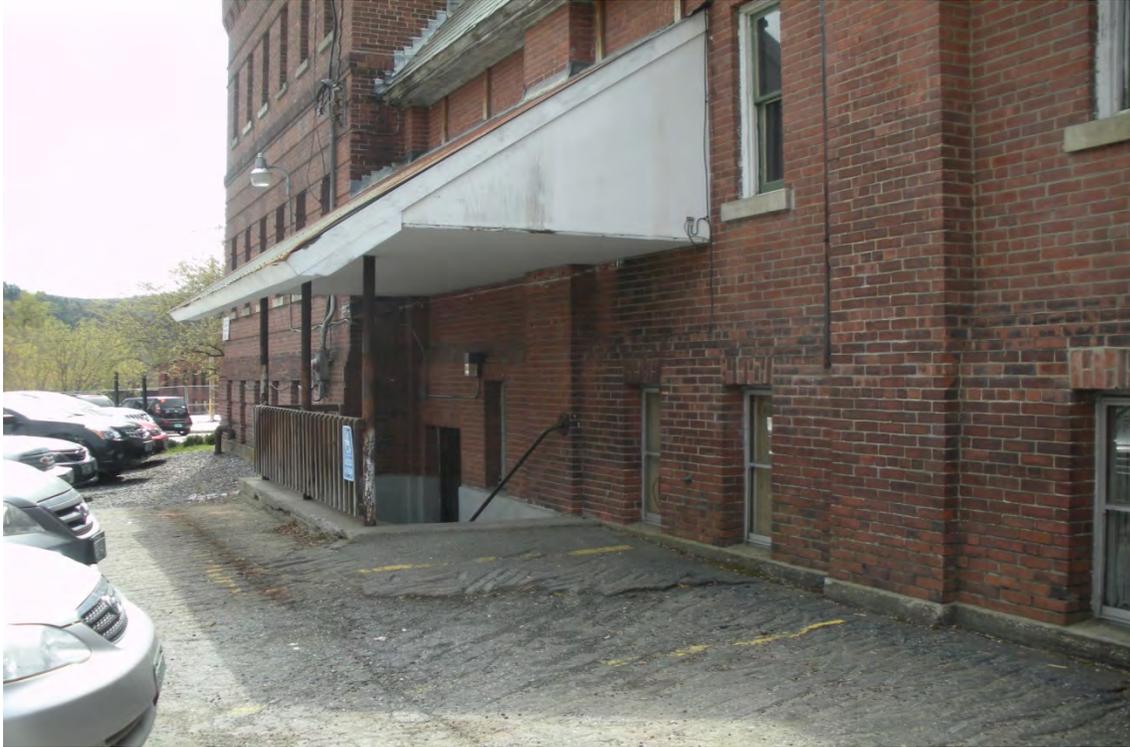
Plate 3. North side of Armory building. Note striations on pavement. These are presumably related to Town's maintenance of ice buildup along exterior wall in winter.

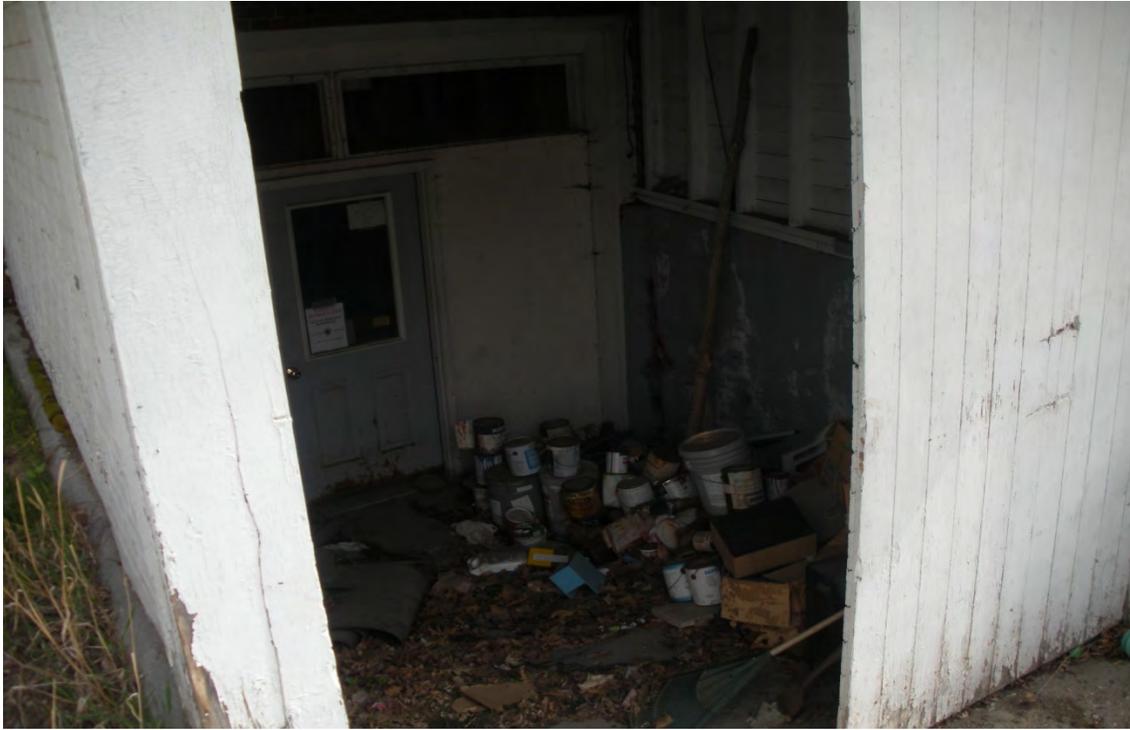
2. A pile of discarded paint cans and buckets (1 – 5 gallon nominal volume) was observed stacked under the roof of the access ramp located in the southwest corner of the Armory building. Although leaks, spills or other visual indications of release(s) from this pile of containers were not observed, there is possibility of surface water and groundwater impacts

should some or all of the containers contain residual potentially hazardous materials that could create an inadvertent spill or leak from this debris.

Plate 5. Southwest corner of Armory building. Covered access ramp with discarded paint containers.

Recommendation: The pile of containerized potentially hazardous debris should be inventoried by a qualified environmental contractor, to quantify and better characterize the contents to determine appropriate management alternatives. Once debris is adequately characterized, the containers and their contents should be disposed of in accordance with State and Federal regulations.

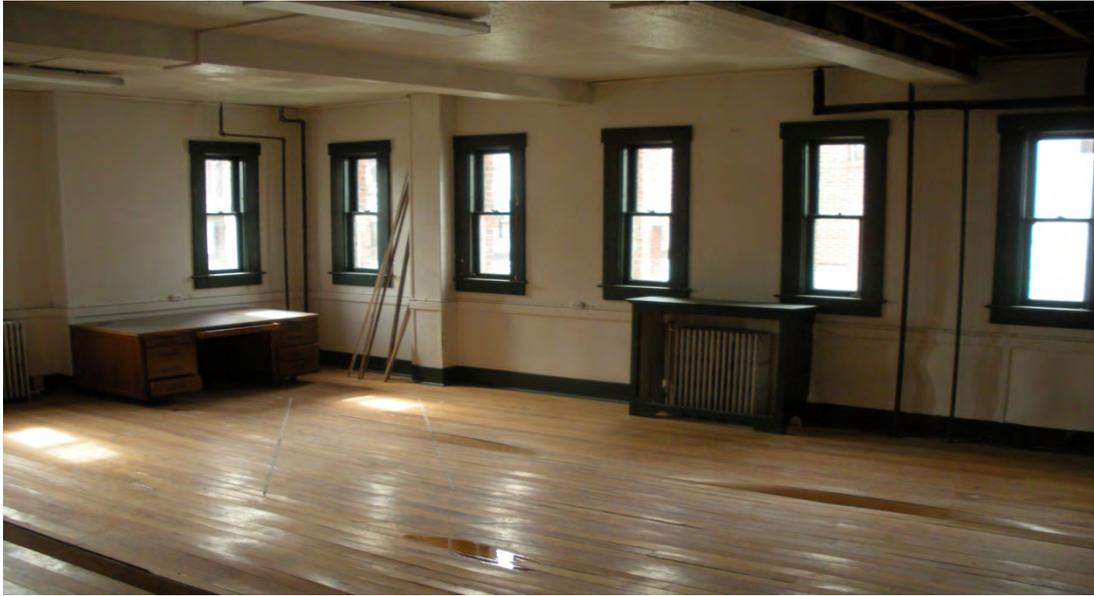
3. Based on information provided in the Environmental Questionnaire (Appendix 3) the Armory building has a mold problem due to constant moisture generated from leaking fire sprinkler lines. According to Peggy Phelps (SJHHC) a mold abatement project was in process to clean up the mold. A follow up call to the Town of St Johnsbury indicated that the project had been placed on hold due to increasing expenditures and no clear end in sight.

Plate 7 Interior of Armory Building April 26, 2012. 2nd floor. Note water on floor from leaks.

Recommendation: Follow up inspection/testing by a certified contractor should be performed to better delineate extent of mold damage. Following an initial inspection and receipt of results of the testing, a detailed cleanup plan should be presented along with estimated costs for completion.

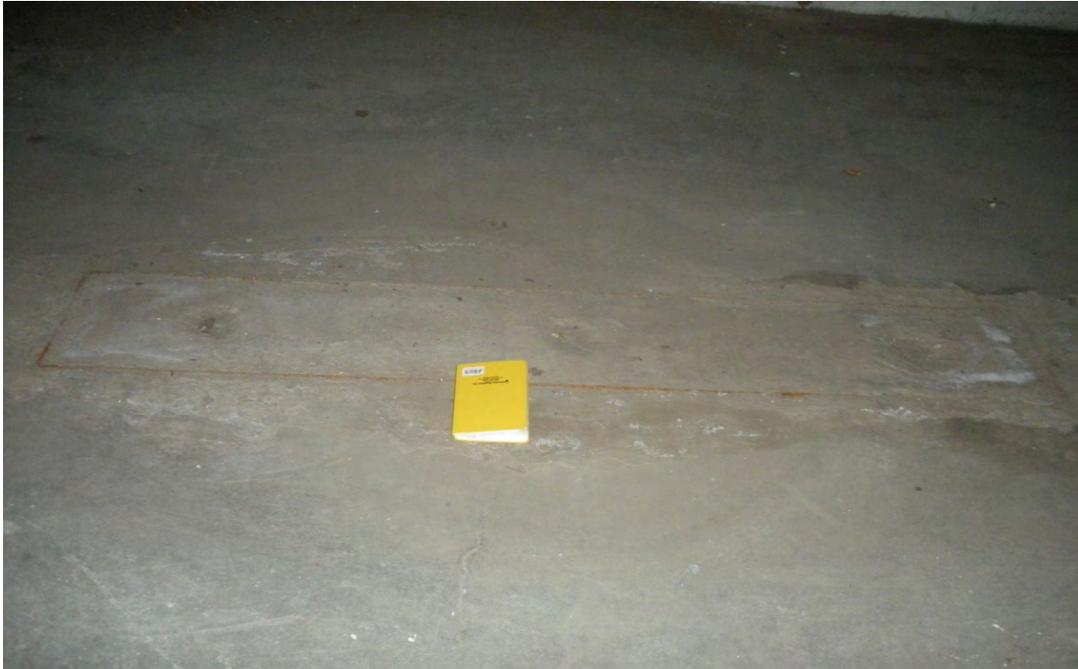
Plate 9. Interior Armory building, basement level, west center. Note filled-in structure suggests former floor drain location.

Recommendation: The pit/floor drain structures should be further inspected for the presence of contamination and to better ascertain what they are connected to. According to Mr. Jim Rust, Town of St. Johnsbury, it was his understanding that the 6-inch iron pipe observed in the pit in the northeast corner is connected to pipe that conveys water from roof drains, however this was not confirmed. Attempts should be made to further ascertain the history of the filled-in structure in order to determine if this was indeed a former floor drain. This would entail review of additional building plans (if available), review of Town sewer lines records in the immediate vicinity of the Armory building (if available) and, attempt to identify and contact personnel with knowledge of the filling process regarding more specific information as to when the structure was filled, and what its purpose was. The follow-up review should be augmented with a dye-test to determine connectivity between the various water collection structures and ultimately an outlet point (if possible). Soil or sediment present or discovered (during additional investigation) in the pit/floor drain structures should be sampled and submitted for laboratory analysis for VOCs and TPH.

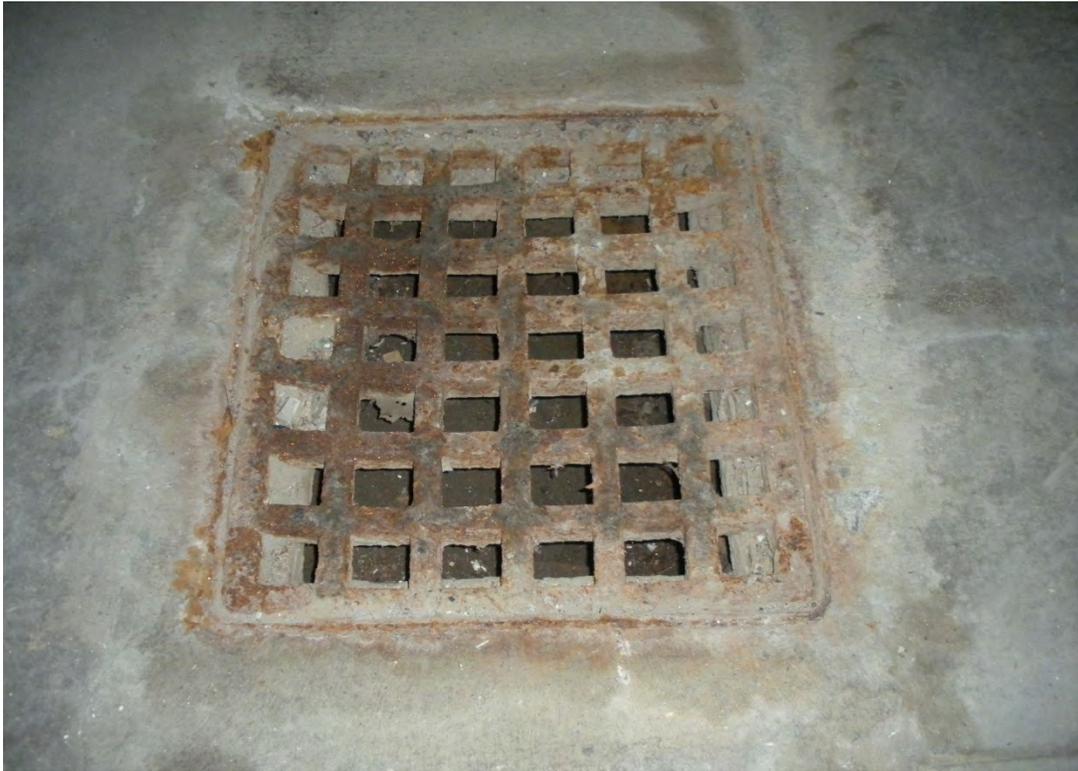
- c. A grated opening observed approximately 8-10 feet north of the aforementioned filled-in structure (in the west-central portion of the Armory building basement) which has an iron pipe (approximately 4-inches in diameter) in the base of the pit under the grated opening. Although not confirmed, the pipe may convey water from the pit toward a sump pump located approximately 5-10 feet to the north. The discharge pipe routed from the sump pump may be connected to the sewer line, although this is not confirmed.

Plate 10. Grated opening approximately 8-10 feet north of filled-in structure in west center of basement.

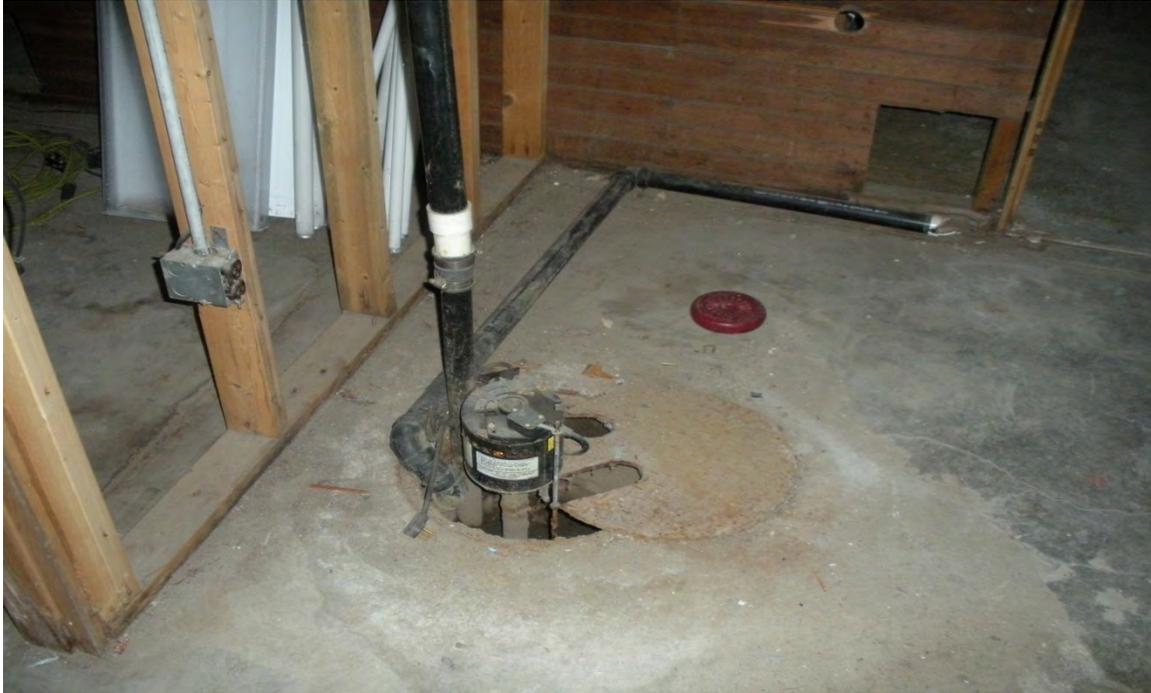
Plate 11. Floor sump pump in northwest portion of Armory building basement.

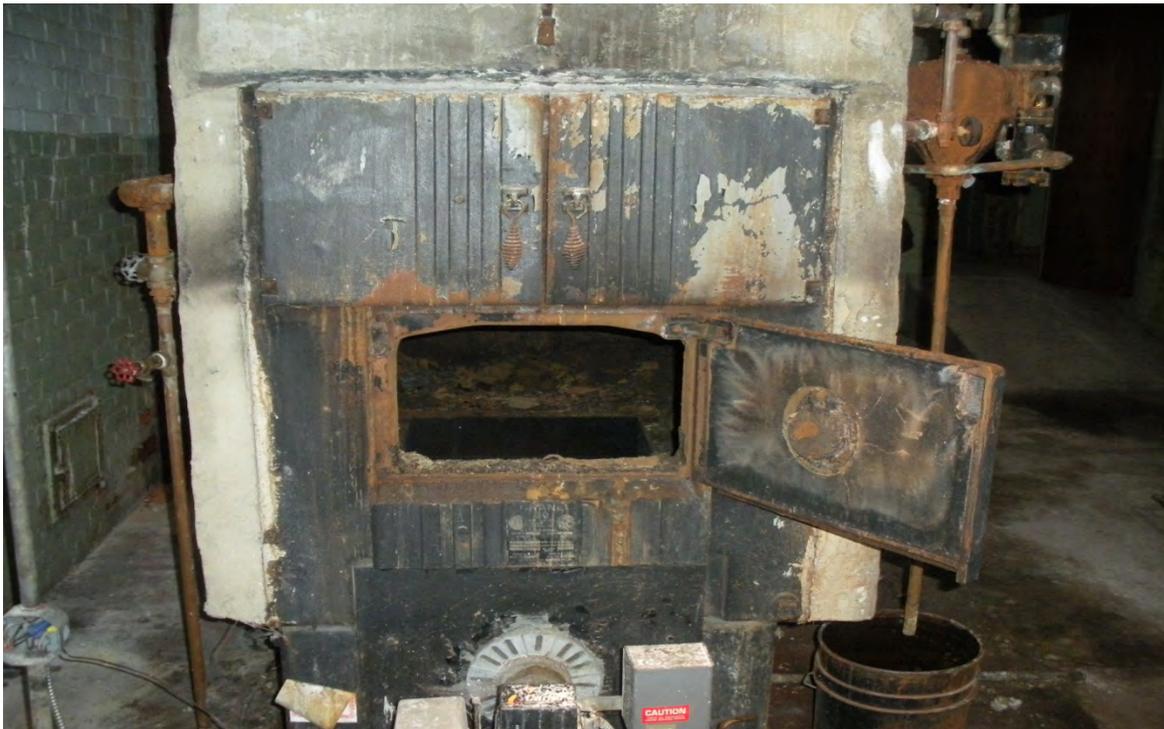
Plate 12. Out of Service boiler with suspect ACMs in northeast portion of basement.

Recommendation: Although a previous ACM inspection has been performed (see Appendix 5), a follow-up inspection should be conducted in anticipation of soliciting formal ACM abatement quotes from licensed contractors. This follow-up inspection will confirm completeness of the previous inspection and identify any potential data gaps.

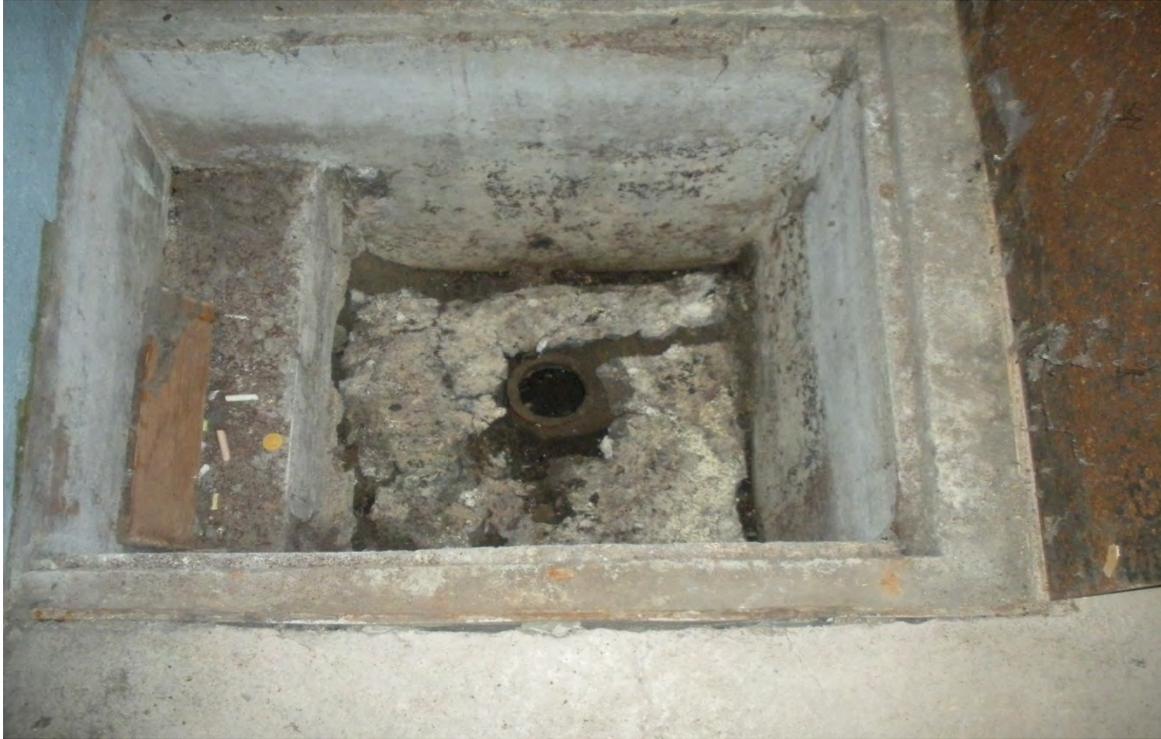
1. Three pits/floor drain structures were identified during the April 26th, 2012 Site reconnaissance effort:
 - a. A pit observed in the northeast corner of the Armory building basement was covered with a ¼ inch thick, removable, steel plate. There is a 6-inch diameter iron pipe

across the bottom of the pit with a vertical 'tee' section protruding upward in the middle of the pit. Standing water was observed in the vertical portion of "tee"; however, no sheens or odor were associated with this water.

Plate 13. Approximate 3 ft. x 3 ft. x 2 ft vault (steel cover lifted off) with 6" iron pipe inside. Located in northeast corner of Armory building basement.
