Area-Wide Assessment

Bay Street Redevelopment Project

Stone Environmental, Inc.

Stakeholder Meeting, Saint Johnsbury Planning Commission

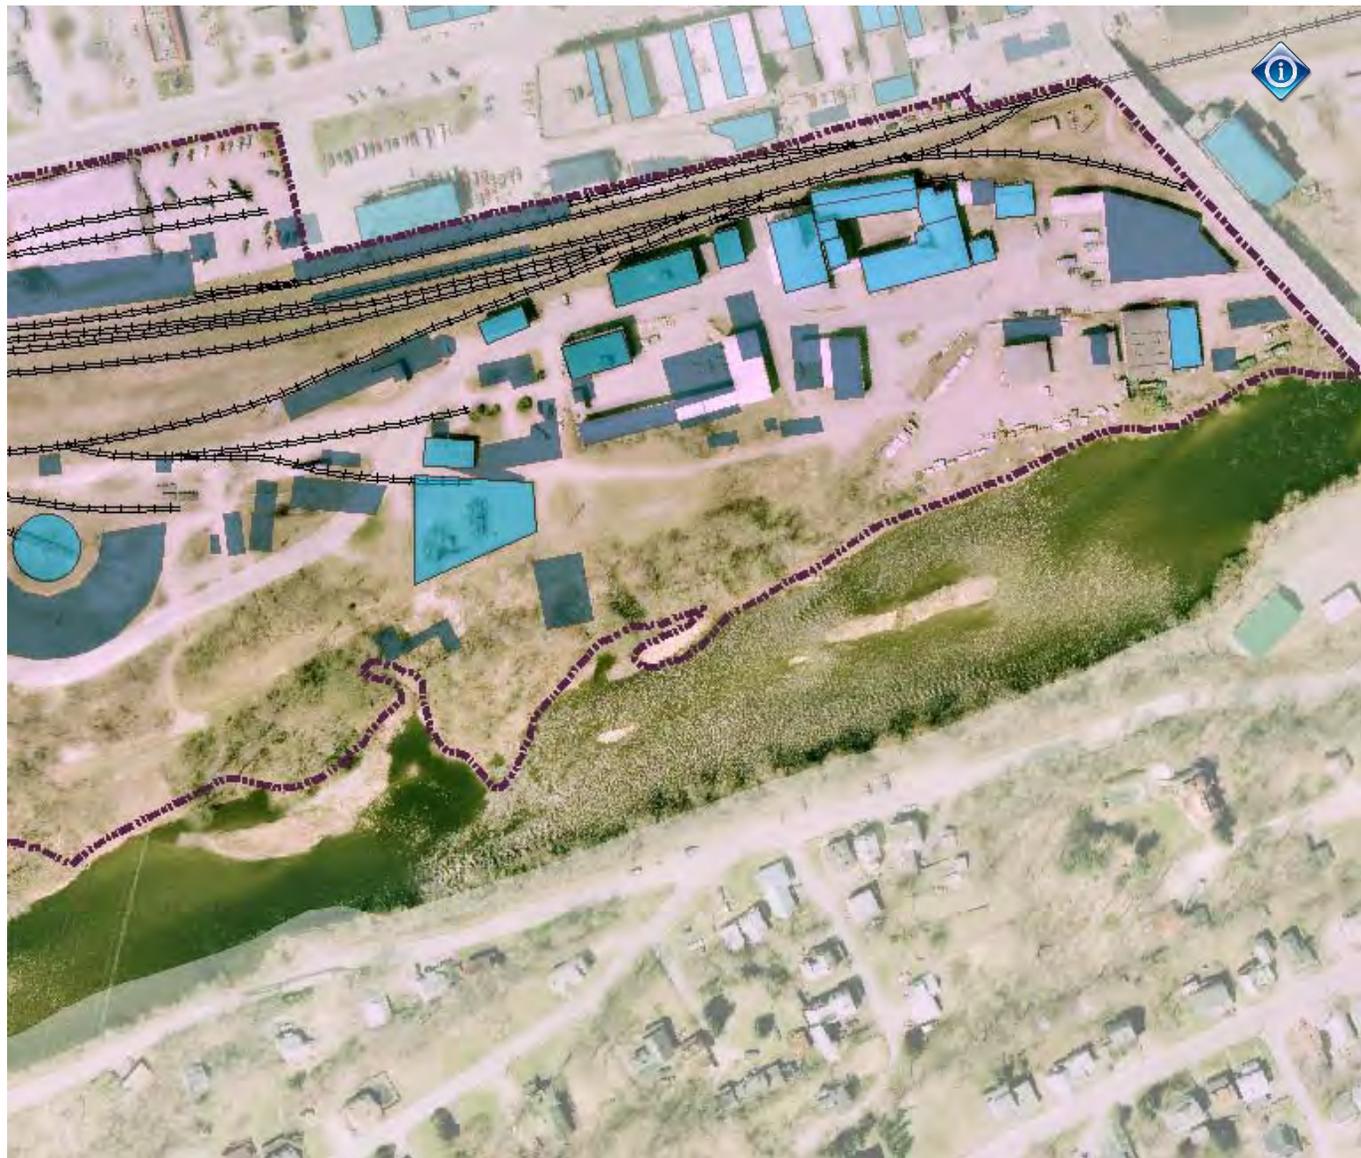
Specific Uses Integrated into GIS

- Historic Use
 - 1934 to 1958 Building Use
 - 392
 - tblUseByYear
 - <null>
 - <null>
 - <null>
 - EN Burnell Storage
 - Hagar hardware and Paint Co
 - MW Debereaux Auto Agency
 - Hagar hardware Co.
 - Hagar hardware and Paint

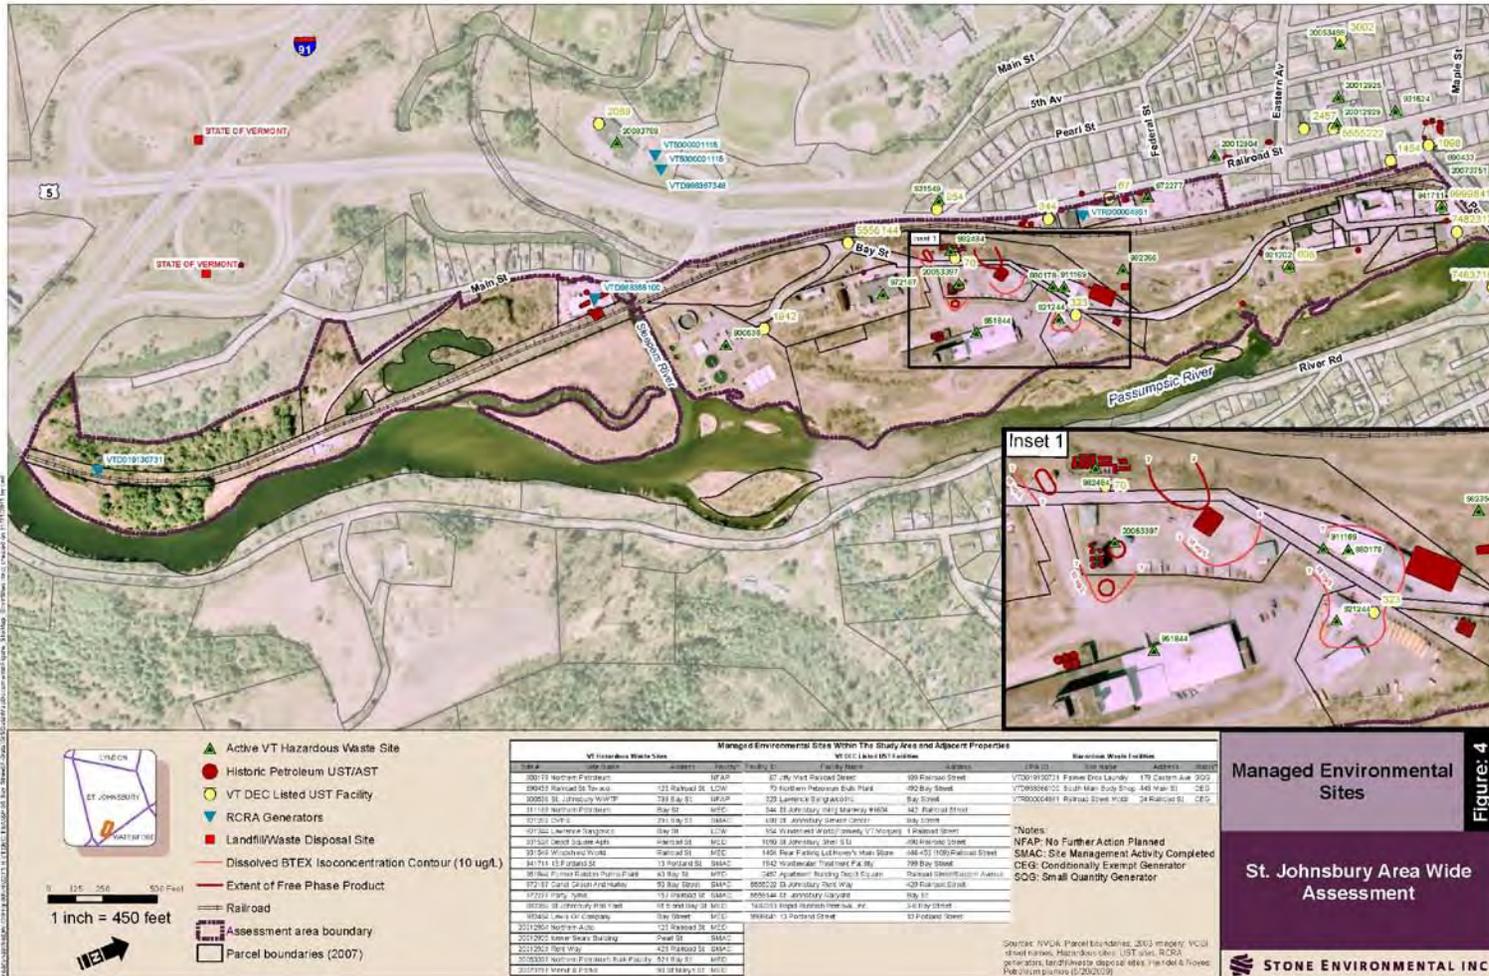
Known Sites

Locations of known contamination in groundwater within the project area

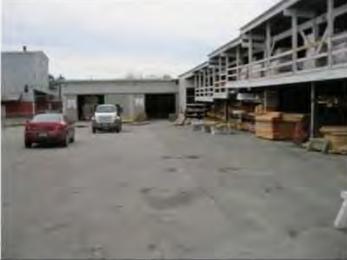
SITE INSPECTION FORM		STONE ENVIRONMENTAL INC	
Project Title	Bay Street Area-wide Assessment		
Client	Vermont Department of Environmental Conservation		
Project Manager	Dan Voisin		
SEI Study Number	092271-R/06		
Site Address:	249, 146, 256 and 258 Bay St.	Town:	St. Johnsbury
Owner/Representative:	Thomas Allen	Other:	Allen Lumber
Contact Info:	802 748 2341	Figure 5 Parcel ID	2
Road Front Photo

<p>Site Description: Three parcel property on the east and west sides of Bay Street. Parcel 1 is the main office and primary lumber yard on the eastern side of the road. Parcel 2 is north of the KC Rentals property and east of the road and contains lumber sheds. Parcel 3 is on the west side of Bay Street and contains a lumber shed.</p> <p>Current Use: Lumber yard.</p> <p>Past Uses: Allens have owned the property since 1960, when they bought the property from Caldbeck & Cosgrove (C&C), which also operated a lumber yard on Parcel 1. Parcel 3 formerly contained a three-story building where C&C manufactured windows and doors.</p>

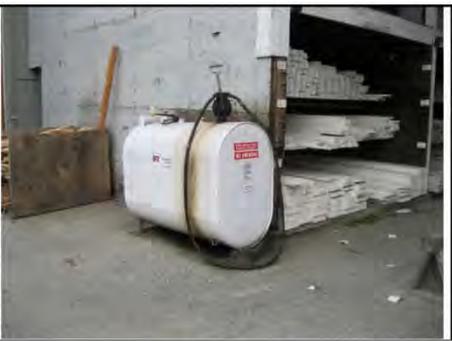
Recognized Environmental Conditions (RECs):		
REC 1: 275-gallon diesel AST in main lumber yard.

Contaminants of Concern: diesel fuel (VOCs and PAHs)		
Other Site RECs, based on interviews, etc.		
REC #	Description	Contaminants of Concern
REC 2:	Location of the Site downgradient of the St. Johnsbury rail yard	All
REC 3:	Location of the Site adjacent to CVPS	PAHs, cresols, metals, PCBs
REC 4:	Past manufacturing on Parcel 3 by Caldbeck and Cosgrove.	Varnish & ketones (VOCs), metals
REC 5:	Past granite manufacturing	Metals, chlorinated solvents, petroleum solvents
REC 6:	Past Coal storage	PAHs
Site Address: _____ Date: _____		
Link to other site photos: _____

- Prior to proceeding with redevelopment activities within the Project Area, complete Phase II ESAs to assess whether RECs identified here have resulted in a release of hazardous materials to the environment.
 - Phase II ESA should augment existing data sets in a way that exposure risk may be evaluated and effective remedial planning can occur.
 - A focus should be made to assess other potential COCs and impacted media that present risk to future users (e.g. vapor intrusion and surface soil).
- Prior to purchasing properties within the Project Area, the Town or prospective purchasers should perform a Phase I ESA in strict accordance with ASTM 05-1527.
- Incorporate all existing and new data using GIS.

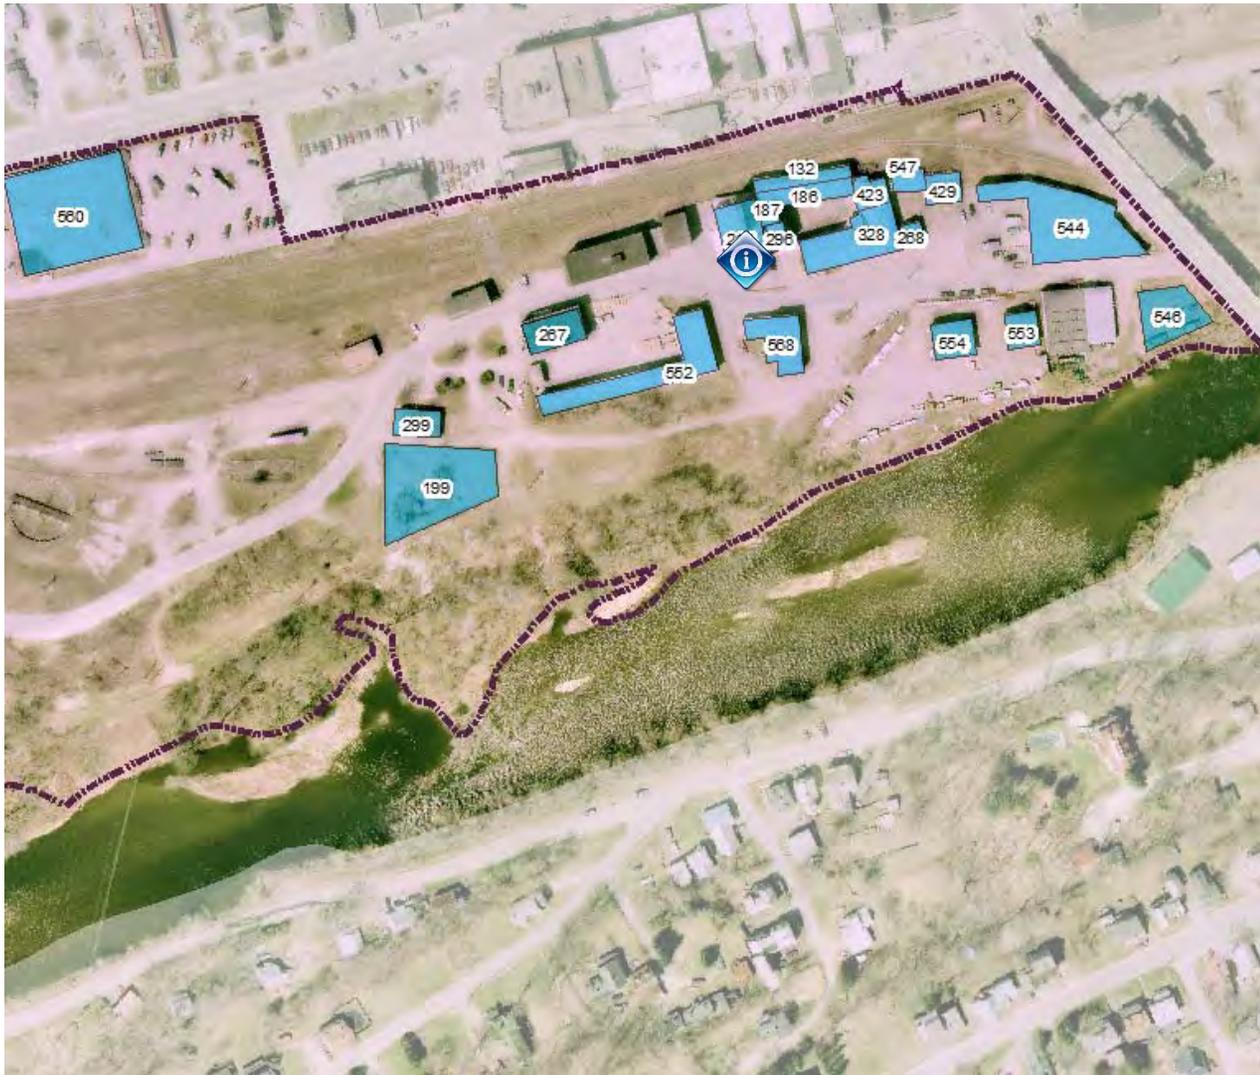
Supporting Documents & GIS

Identify from: Building footprints
